**Tower Houses in the Carra Barony of County Mayo:
A Condition Review.**

Dissertation submitted in part of the Requirements of the BA of Arts in Humanities in
Heritage Studies at GMIT Castlebar, 2009.

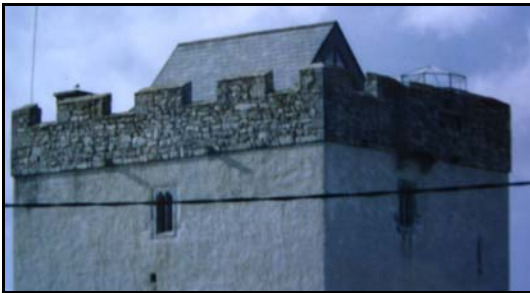
**Fig 4 Simple stepped Crenellations
Turin, Kilmaine, Co. Mayo**

There are many different styles of crenellations in Irish tower houses. They can be simple stepped crenellations (Fig 4) or Irish style Crenellations (Fig 5).

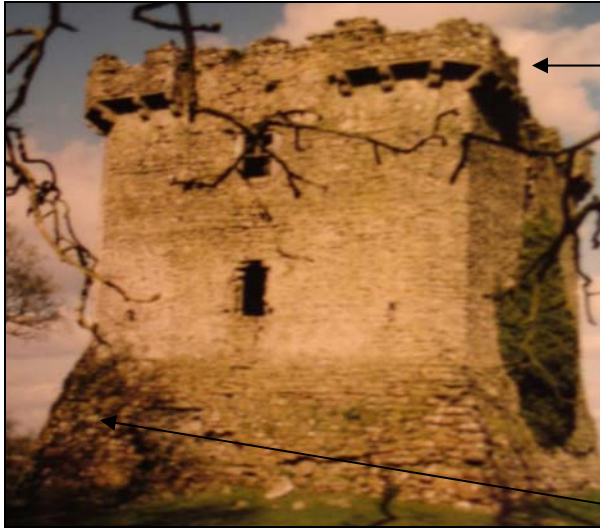
Bartizans or corner projections on Shrul Castle, Co. Mayo. These examples are circular, but more commonly they are square/rectangular (See Fig 5). Machicolation are similar projects over the doorway.

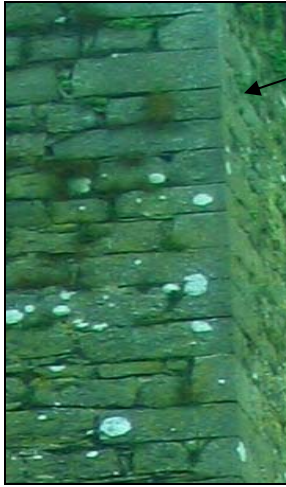
Figure 7 Castle Burke Quorin stones.

Quoirn stones are corner stones. These are commonly dressed stone.

Quoirn stones from Castleburke.
Quoirn stones from Ballyhowley Castle, Knock.

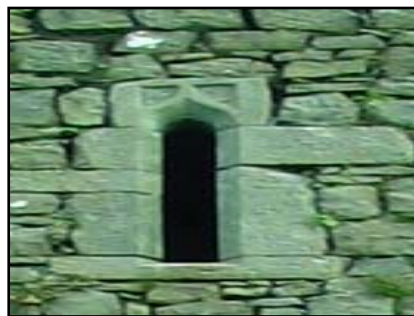
Figure 9 Castleburke Ogee headed window

This example is from Castleburke. These are very common windows in tower houses.

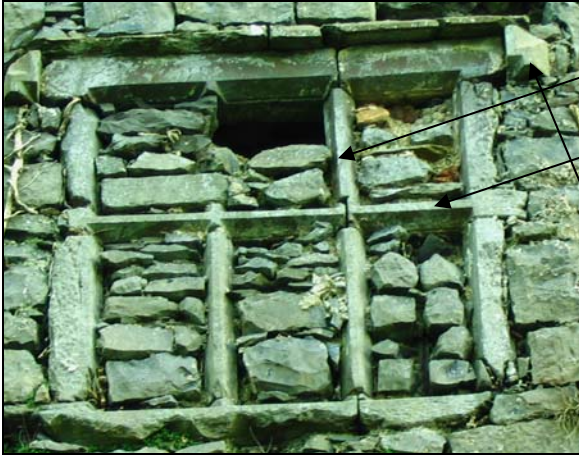
Fig 11 Mullion and Transome window, Castleburke.

Mullions are the vertical divides in the window while the transome are the horizontal divides. These are usually found on the upper floors of tower house as they are not as defensive. The remains, of what Leask describes as moulding can also be identified around the top of the window.

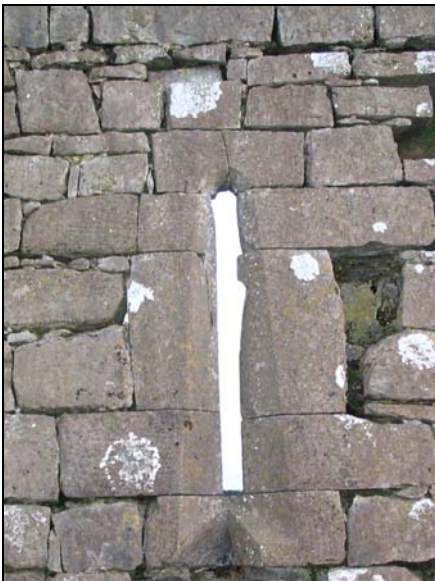
Fig 12 Loop from the exterior Doonamona.

Loops do let light in but they also have a defensive function. Loops are usually wider in the interior and narrow to the exterior of the building. This way arrows can be fired out, but the space is too narrow to allow them back in. Loops are usually found on the lower floors of tower houses. They may sometimes have a widening in the centre forming a cruciform shape these are commonly referred to as cross loops. Later these loops were adjusted for guns.

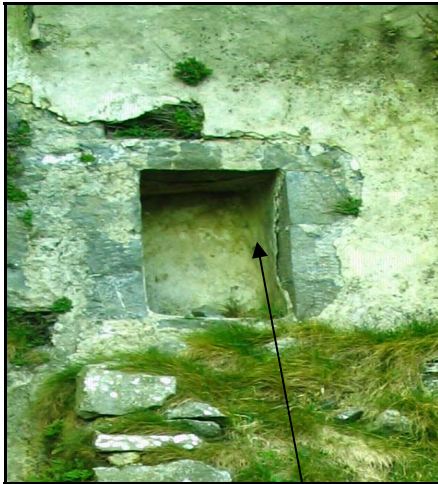
Fig 14 Castleburke Aunbries in N wall.

Amburies are cupboard like spaces found in the walls of the castles. They are common features in Irish Tower houses and can be found in both Castleburke and Doonamona in the sample.

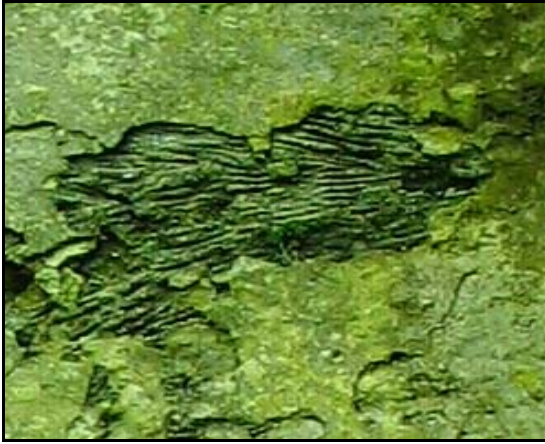
Fig 16 Wickerwork, Castleburke.

Remains of wicker within the plaster is also a common feature in tower houses and can be seen at Castleburke. Wicker mats were used to support the vault during its construction. This wicker was simply left in position and then plastered over. Often when the plaster begins to fail, the imprints of the wicker or even the wicker itself can become visible on the wall⁸¹.

Evidence of wicker centricing in
Castleburke

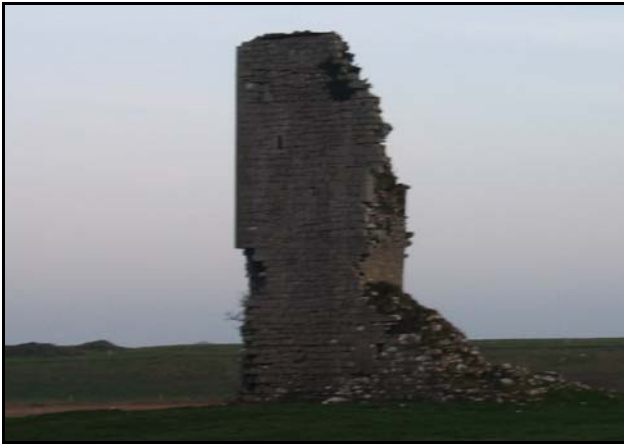
Figure 19 Doonamona from the N W.

The interior of this castle is also in poor condition. There is no evidence remaining to indicate the internal layout of this castle. There is considerable vegetation growth on this face.

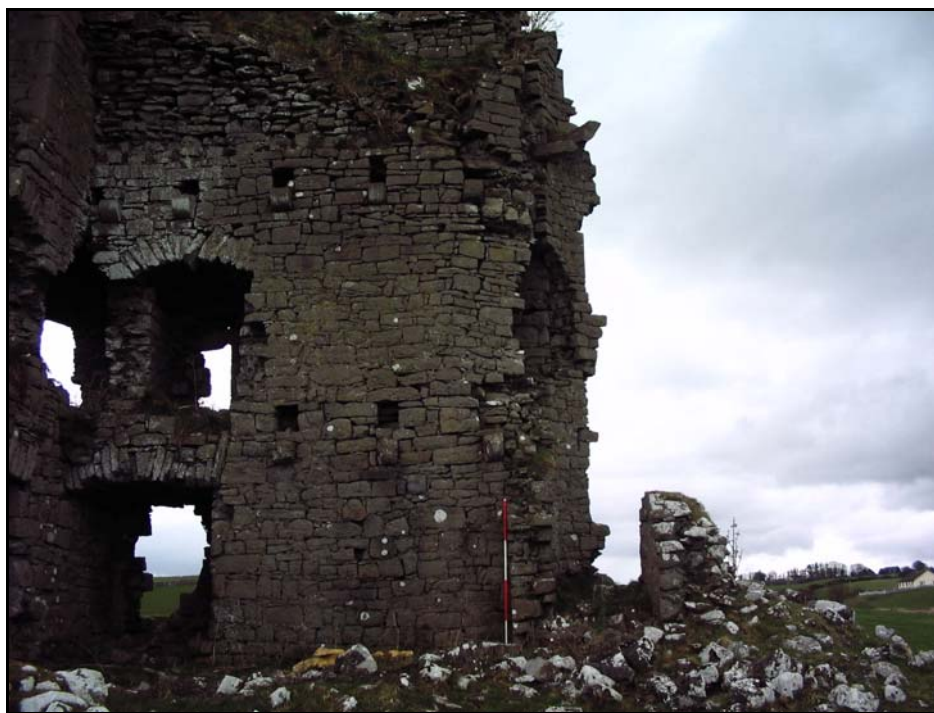
Figure 21 The interior of the N.E Wall

The main feature on the N.E wall is the remains of the spiral staircase (Fig21), (Fig 22) and the remains of a hanging eye (Fig 22). Eight corbels are also found on the N.E interior wall as well as the remains of a vault at the third floor level.

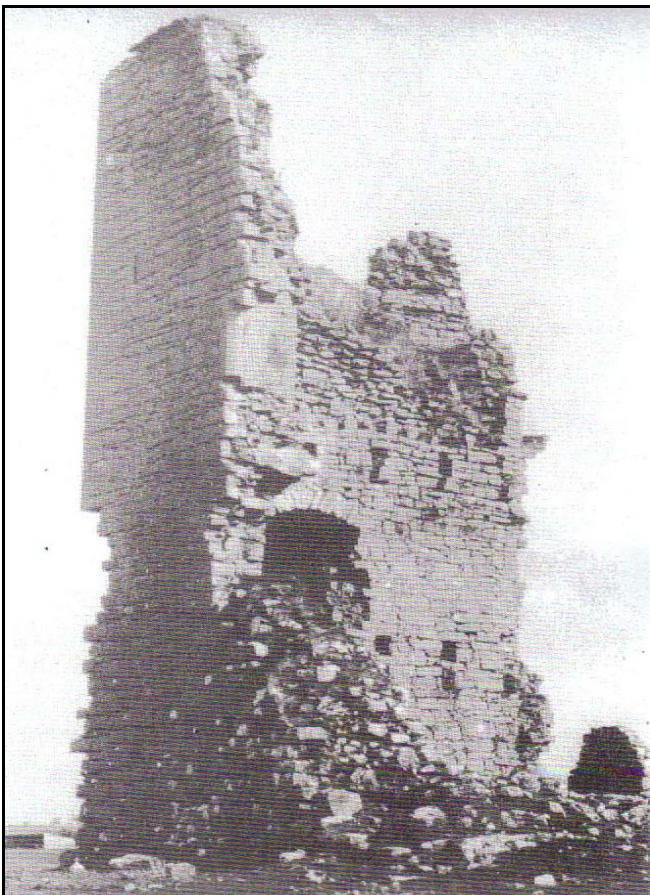
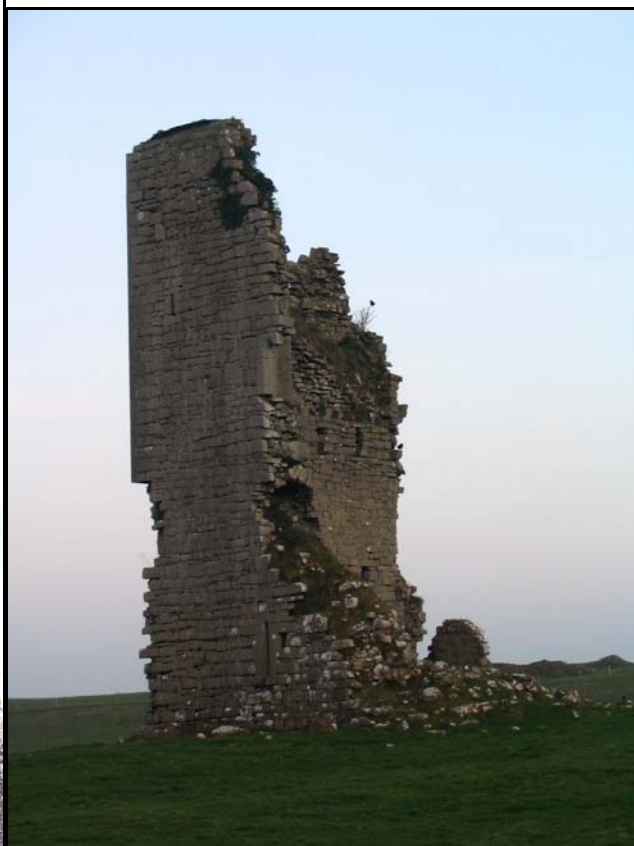
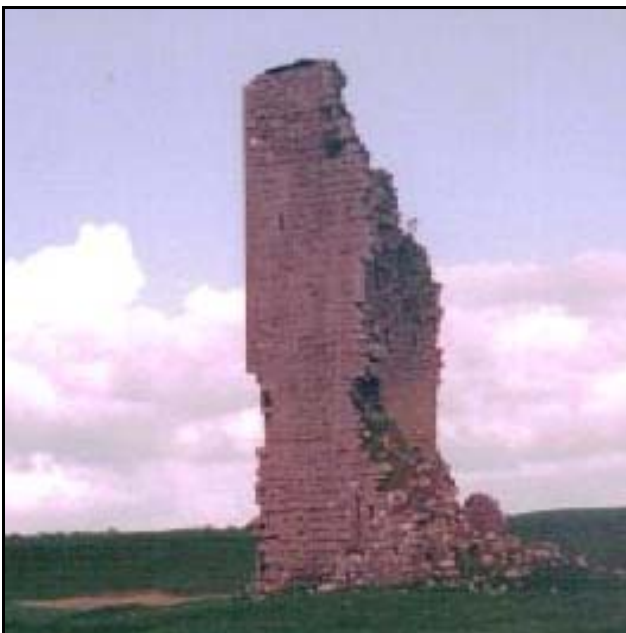
Comparing the photos there appears to be little difference between the castle except that there is some material missing from the upper level and there is substantial plant growth.

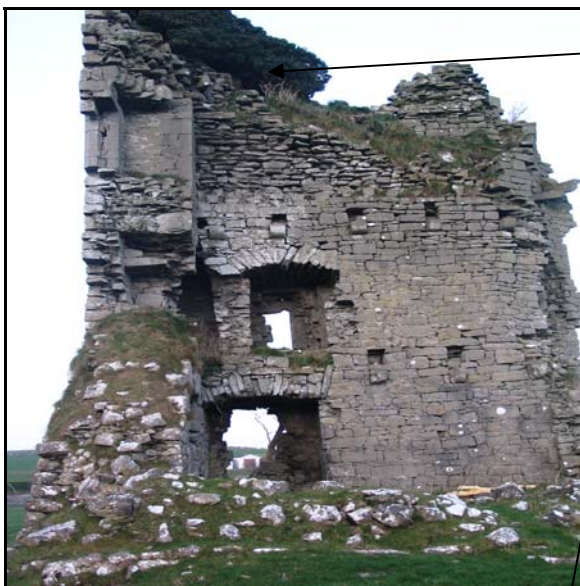
Figure 26 Doonamona N.E wall from the S.W.

A mural passage measuring 5m in length is identified in the 1988 survey. This passage is no longer visible due to vegetation growth and possible stone collapse.

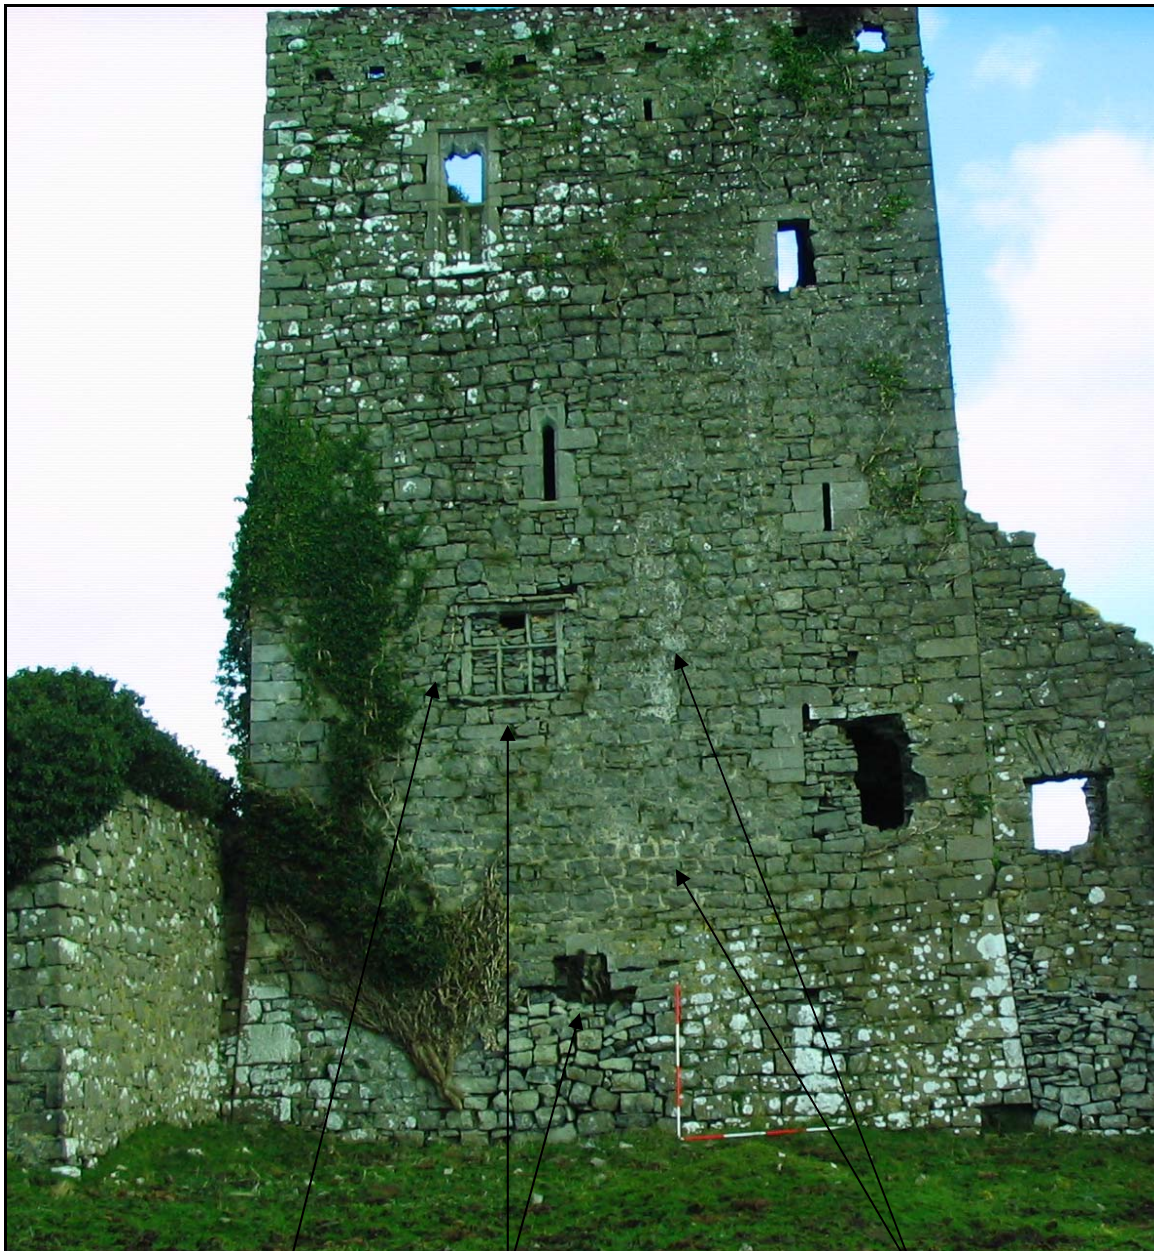
Figure 29 Castleburke W wall

Large mullioned and transome window probably a later addition.

Original window have been in filled.

Clearly ivy has been removed from this building and these areas have been repointed.

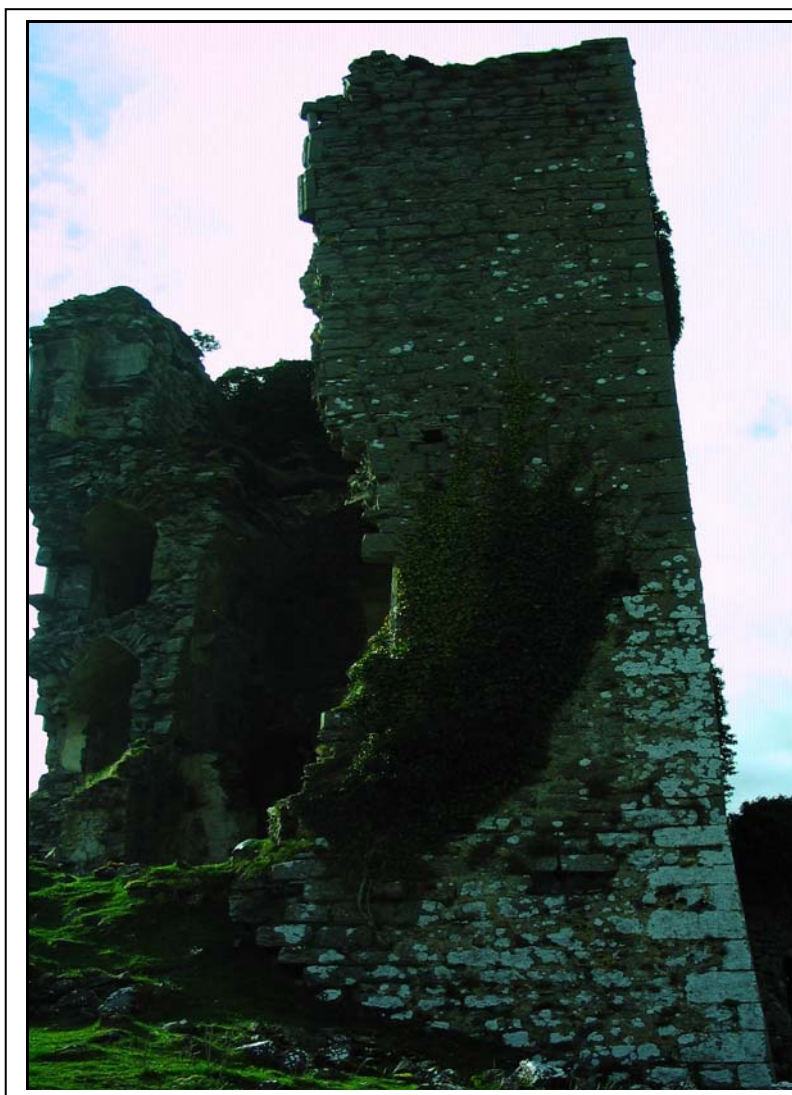
Figure 31 Due to the collapse of the E and S wall a cross section of the interior of the castle is visible

The southern side of the east wall has collapsed. There is some vegetation growth and limited features. There is also much lichen growth.

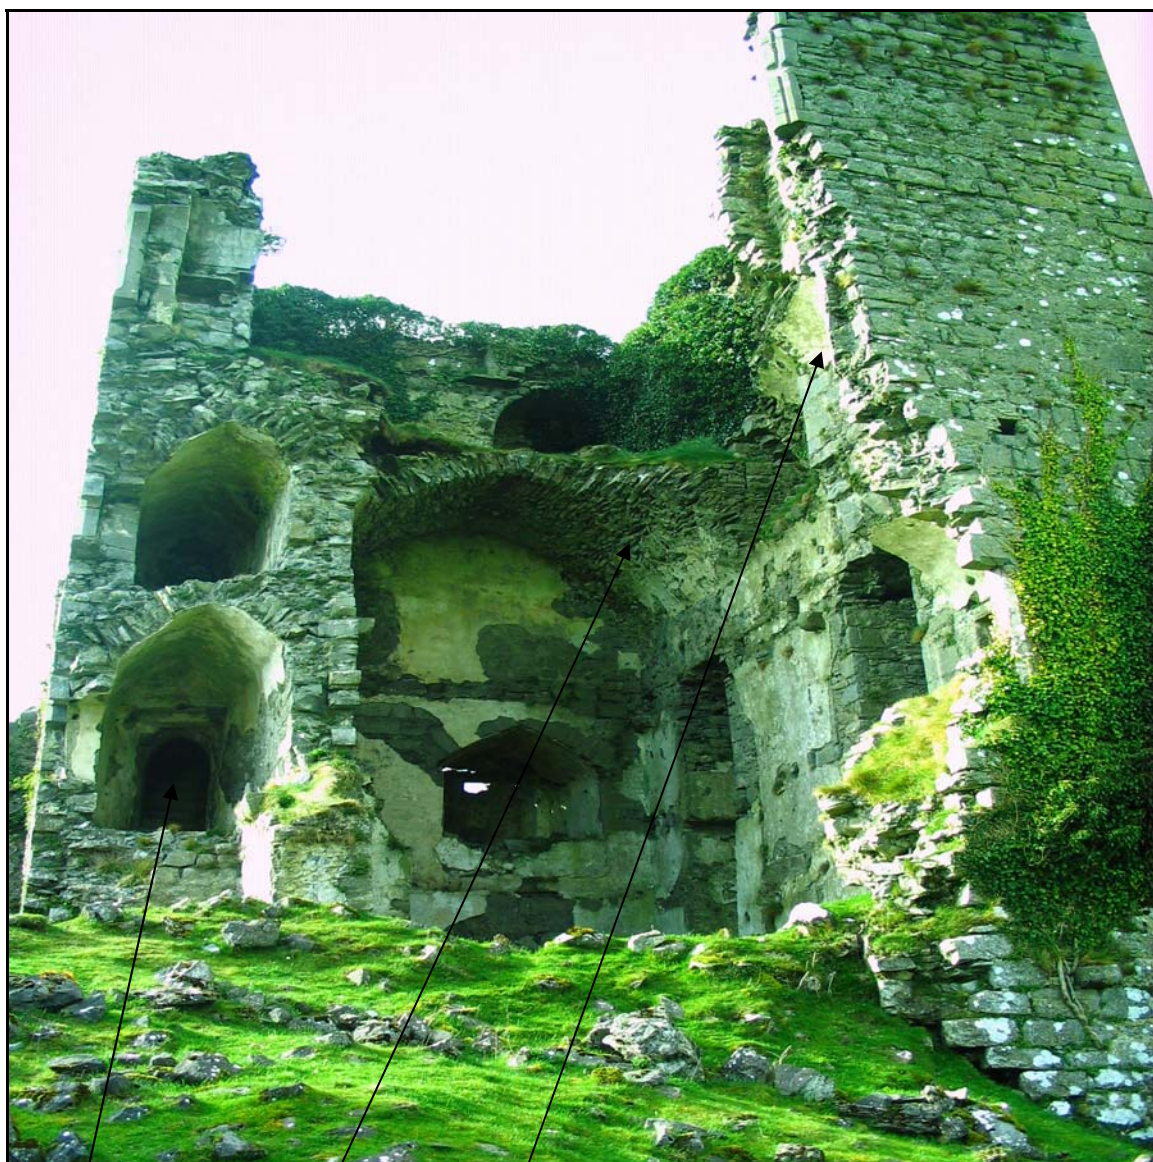
Because of the collapse of the S and the majority of the E wall a cross section of the castle is visible (Fig 31). Many features are still visible including two mural corridors, a spiral staircase (Fig 32 and

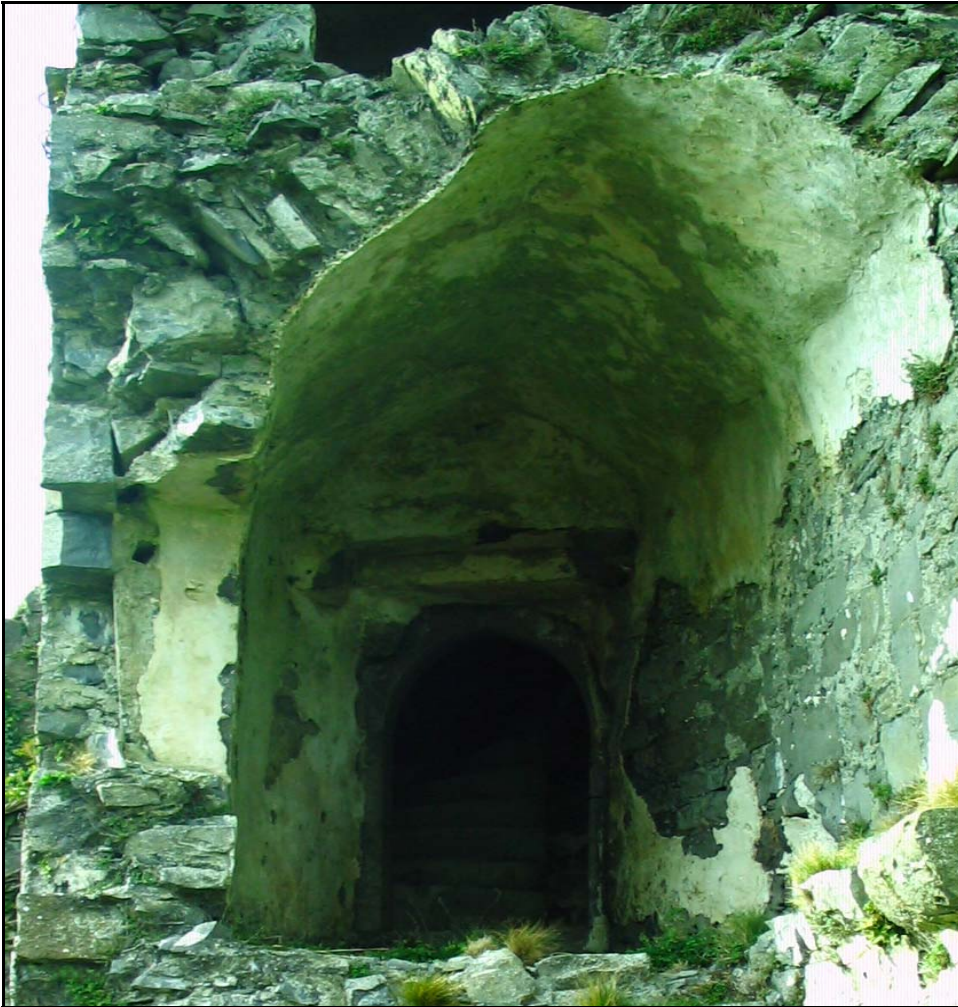
1. (Figure 33)

Surviving examples of plaster can be seen in this mural chamber as well as the staircase through the doorway.

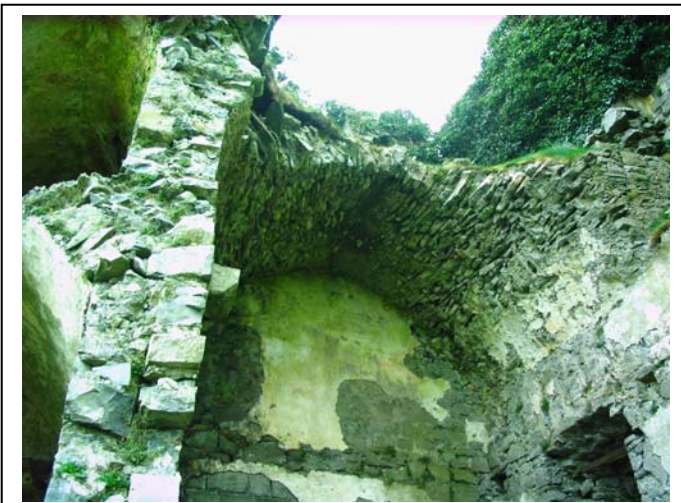
2.(Figure 34)

Part of the vault supporting the upper floor survives. Due to vegetation growth, however, it is difficult to decipher features in the upper floor.

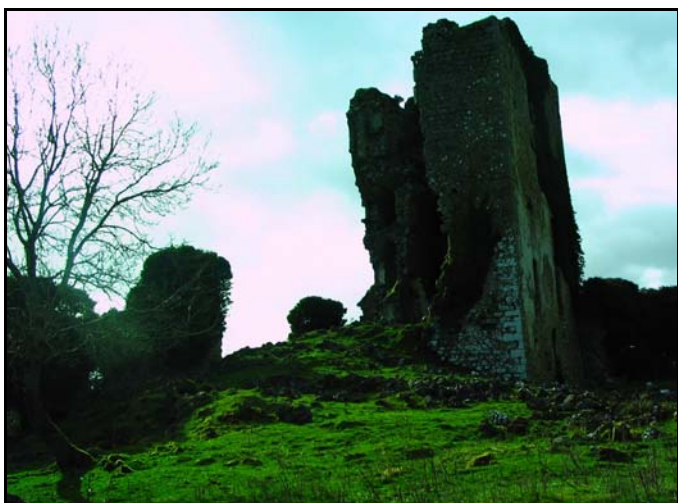
Fig 37. Castleburke today from the N.E.

The most notable change to this building is the collapse of the E and S walls. Prior to the collapse of these walls this tower house was in very good condition. A survey carried out by Lavelle et al in 1987/1988⁹⁸ gives a description of the interior of the castle especially in the upper floors that are no longer visible due to vegetation growth. *Archaeological Survey of Ballinrobe and District*,⁹⁹ a survey carried out in 1991 and the earlier survey by Lavelle, both identify a mural chamber and a guarderobe, which due to vegetation growth or stone collapse are no longer visible. A survey carried out in 1945 describes the interior with a complete vault as well as a fire place in the east gable, which no longer survives (see Fig 38).

Castleburke before the E and S walls collapsed. The photograph below shows Castleburke today.

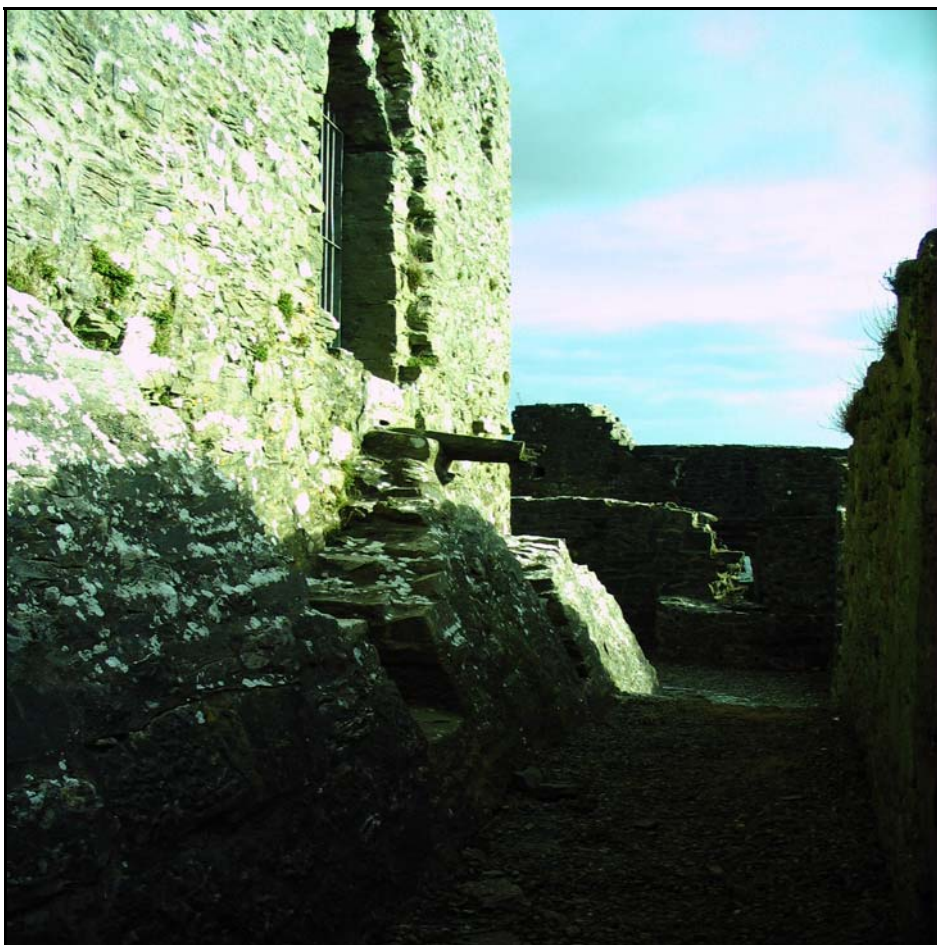
Figure 40 The W wall from the N.W

The fragmented bawn is clearly visible. The water shoot under the window was placed there during O.P.W conservation works. An additional building in the south of the bawn is visible in the background.

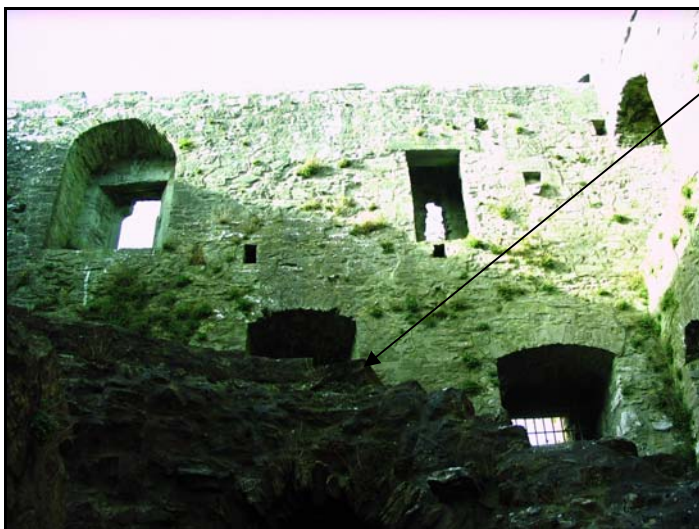
Figure 41 The Interior of the N wall.

There are also many features preserved on the N wall (Fig 41). The presence of plastic also indicates that a lot of this wall has also been rebuilt

Remains of the arch that leads from the entrance chamber to the back chamber.

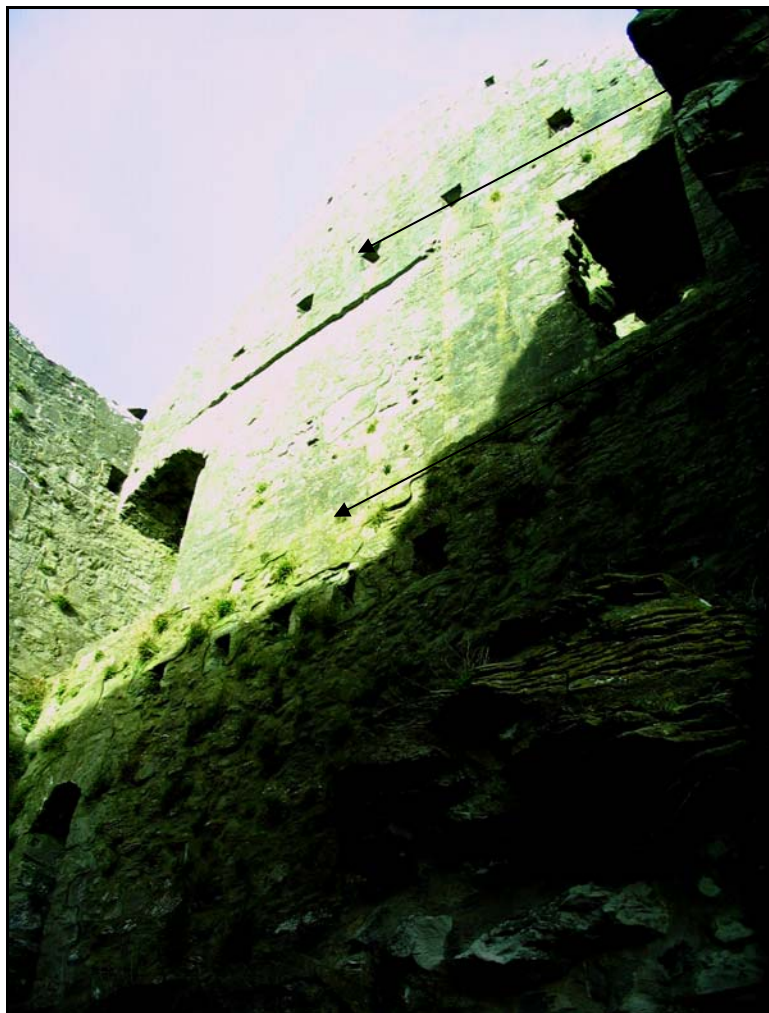
Surviving Joist holes.

The O.P.W carried out conservation works which included making the first floor a concrete platform.
